Town of Hilton Head Island Regular Design Review Board Meeting

Tuesday, January 10, 2012

Re: Safety and Longevity of Palms at Marriott Grande Ocean

PROJECT NAME: _Marriott Grande Ocean

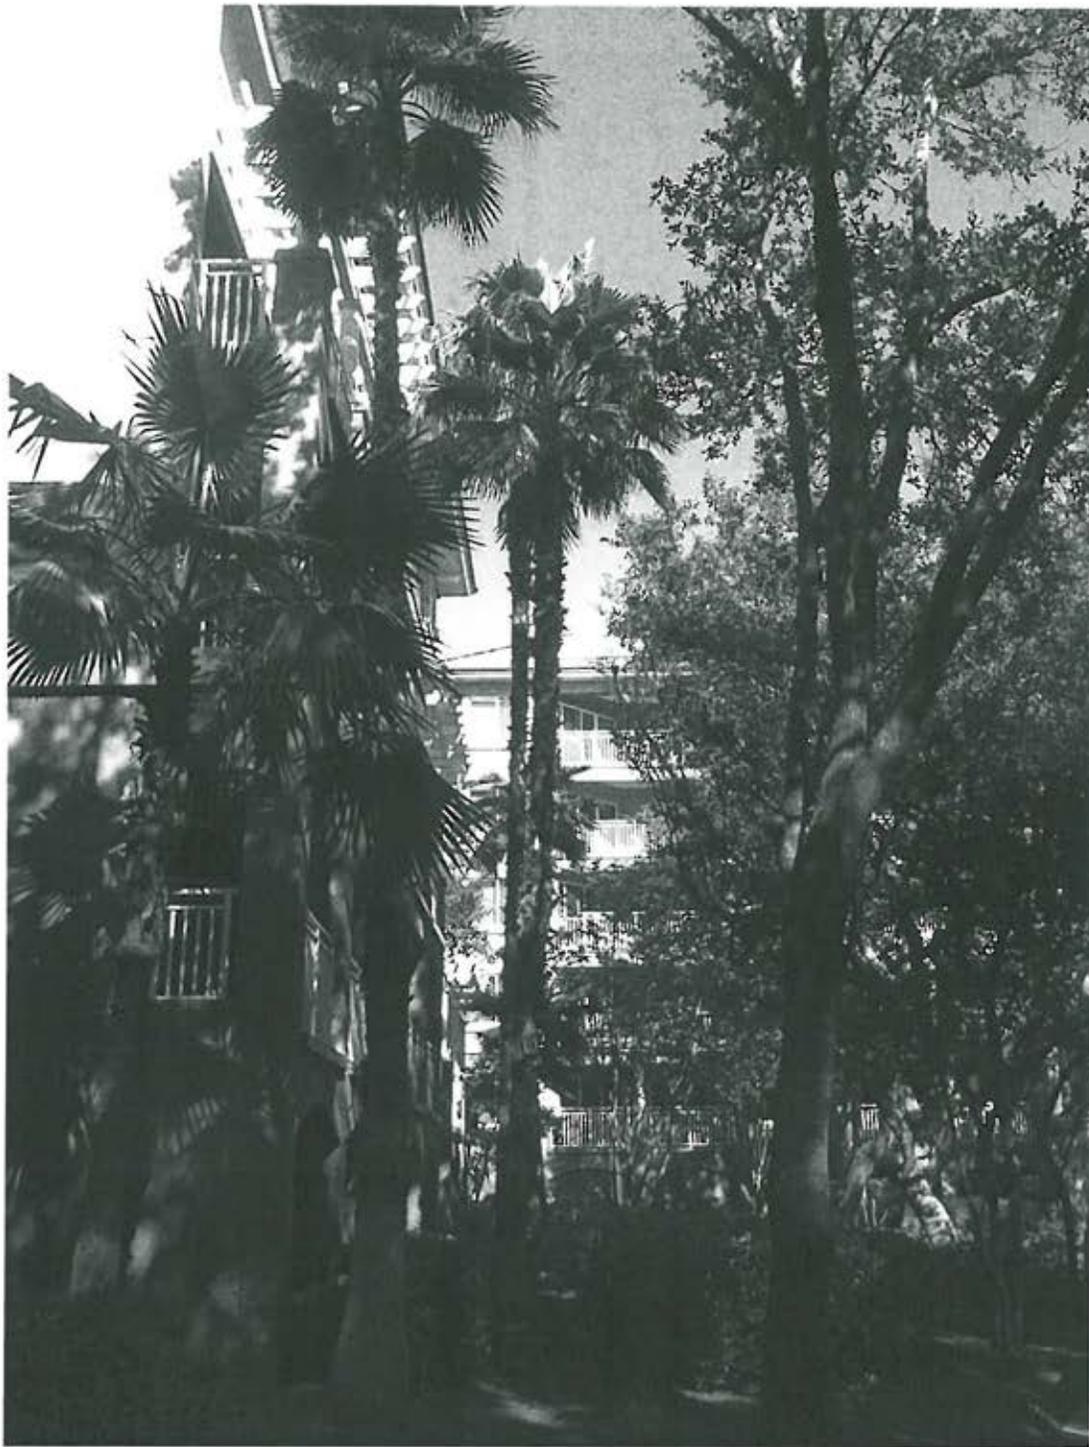
The *Washingtonia sp.* that is concentrated in the courtyards has developed in a shaded location dwarfed temporarily by large Live Oaks that were native to the site at the time of construction and the palms' planting. These palms were subsequently forced to grow at a more rapid pace in order to stretch for necessary sunlight to photosynthesize. This rapid growth caused a tapering of the trunk as they did not allow themselves to develop trunk girth equal to that put on during nursery/field development which reduces the structural integrity of the palm. They now extend over the Oak canopy which exposes them to more direct ocean breezes that create a large sway in the trunk of the tree. This coupled with the fact that the trees were planted less than four (4) feet away from the building, see Appendix 1, and have a growth habit of 10'-15' of spread these trees are now being pushed into the balconies and façade of the building posing a risk to structure and guests. *Washingtonia sp.* are also susceptible to root rots and fungal infections, such as, Ganoderma which can cause rapid decline or complete failure of the tree at the base. This is especially present when the palms are planted in areas of high moisture exposure, i.e. irrigation to surrounding plant material, and low levels of sunlight to dry soils out, the palms are squeezed between dense Live Oak canopies and six story buildings, thus allowing fungi to breed more readily.

Appendix 1: Washingtonia palms planted too close to structure and not allowed to have room to move in heavy winds

The problems associated with these palms are not easily correctable, if at all; do to their location, existing hardscapes and mature landscaping, and lack of access to safely move the trees that present a potential risk. Therefore it is advisable that these select trees be removed from the site before more damage is done to the structures and limit future hazard to guests of the resort.

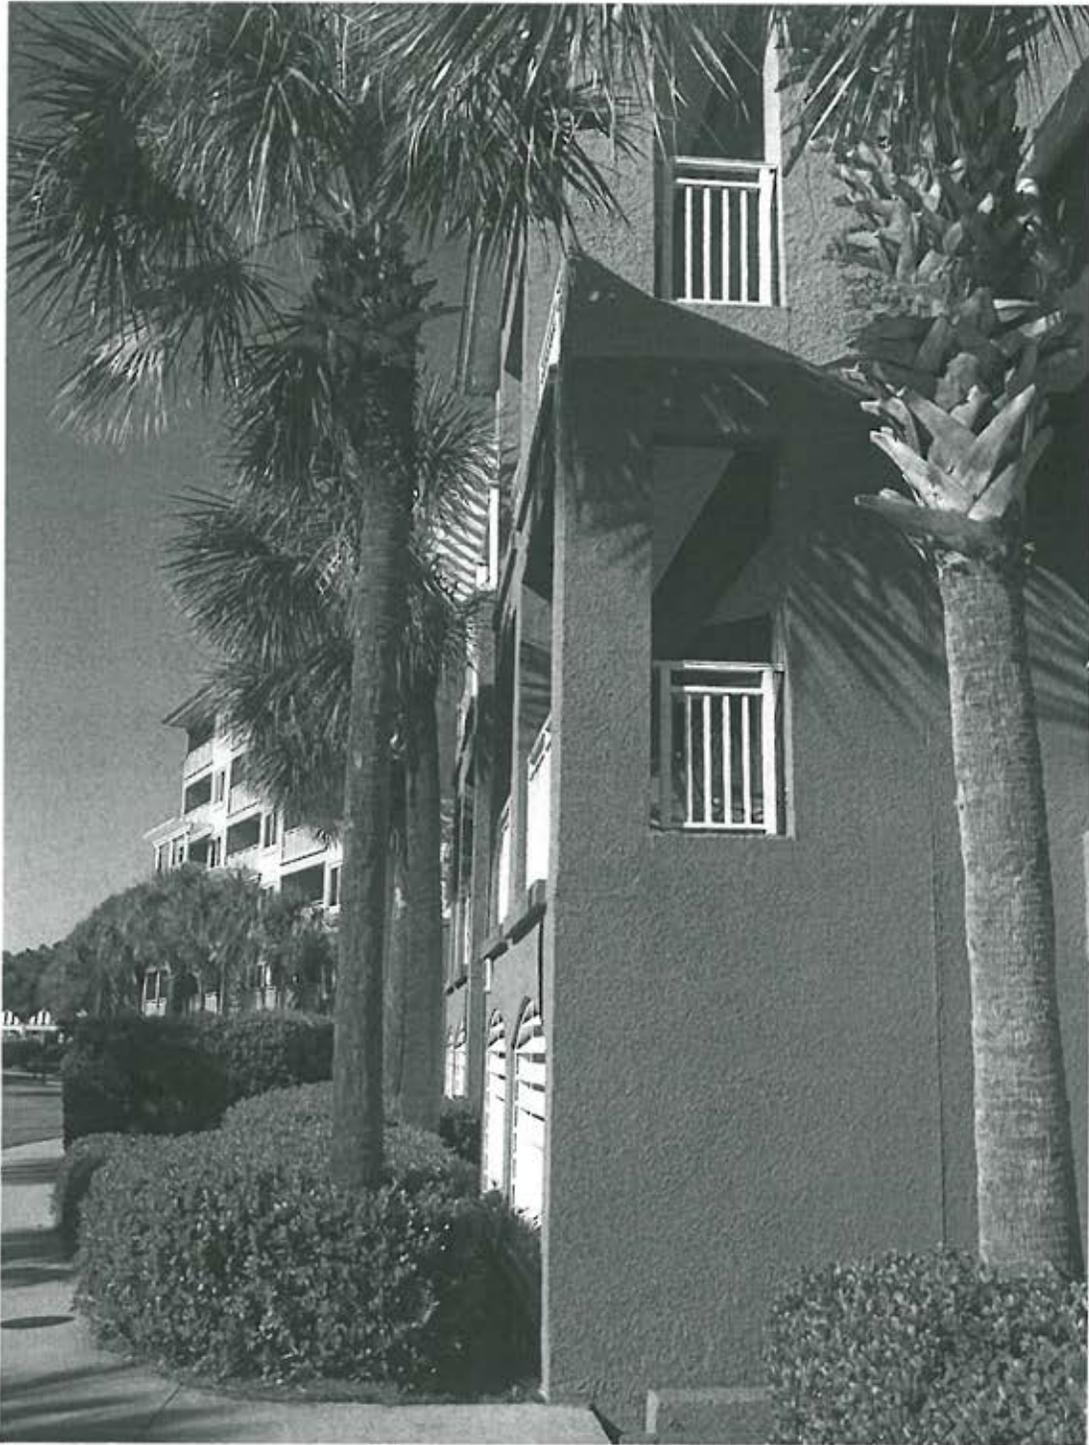
The *Sabal sp.* is more prevalent throughout the property than the *Washingtonia* but it has also incurred problems in certain areas caused by poor planting techniques and lack of proper developmental space. Many of these palms were planted less than four (4) feet away from buildings/awnings and have the same spread of 10'-15' as the *Washingtonia*. This placement so close to buildings has created a need to prune one side of the palm every few months versus the once a year pruning that the opposing side needs to remove dead/declined fronds and seedpods. This need to prune is brought about by the

fronds along the side of the building being in constant contact with the structure. This creates a pathway for insect activity and rodents onto guest balconies and rooms, see Appendix 2,3. In addition, their direct exposure to ocean winds causes banging and slapping of the fronds against the structure, as well as, taller palm trunks hitting awnings. The location of the palms and need to constantly prune them will manifest itself into a much larger problem in the future. The removal of excess fronds from the upper portions of the palm head has created a "pencil point" effect where the trunk diameter begins to narrow as years go by and the trunk does not have the time and energy necessary to develop fully, see Appendix 4. Continual growth like this will create a very weak and narrowed trunk that does not have the structural integrity of the original stem. This coupled with the constant exposure to the ocean winds can cause them to snap off putting the building and guests at risk should it fall onto the balconies or the sidewalk below that many of these palms lie along.

Appendix 2: Sabal palms planted too close to structure and growing into guest balconies

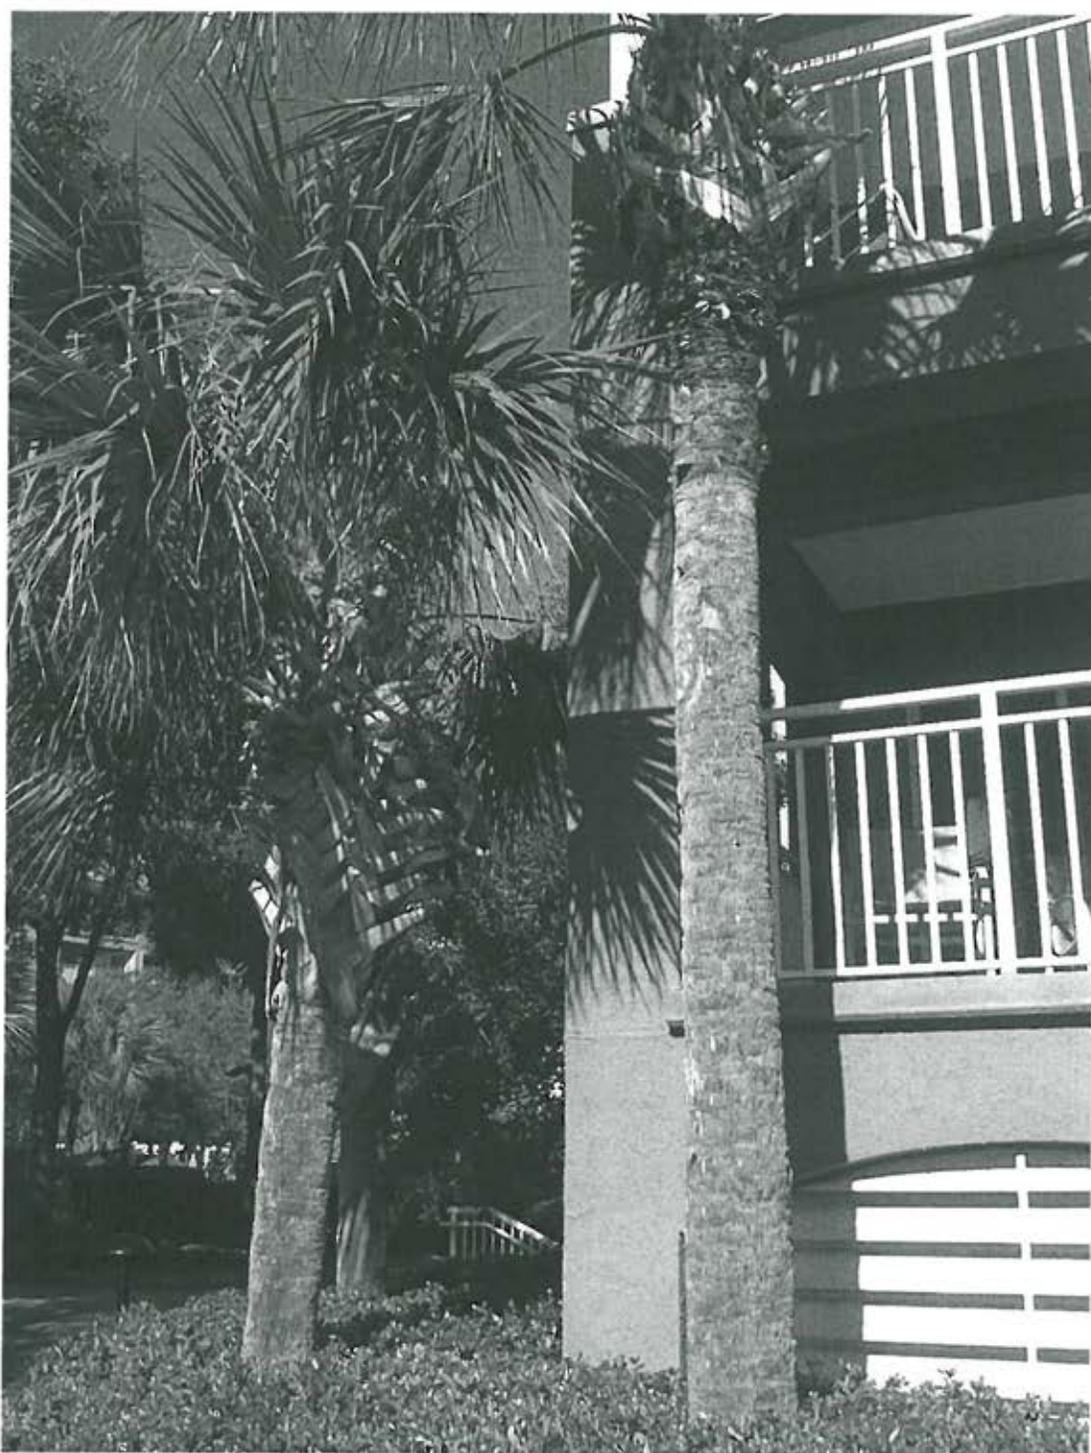
Appendix 3: Sabal palms to close to balcony having to be pruned severely on one side

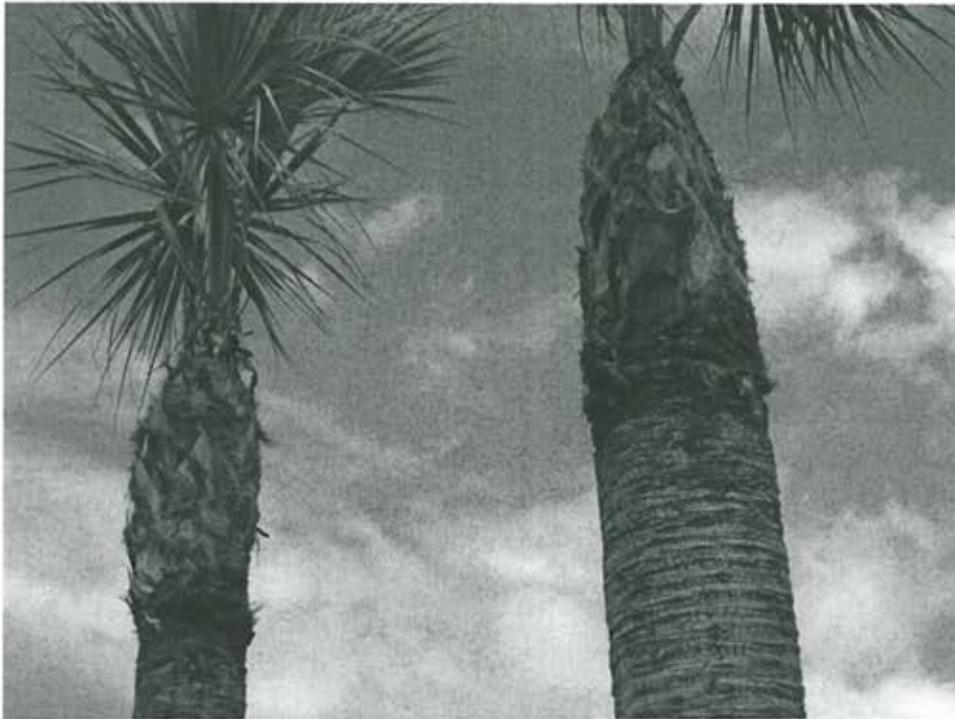
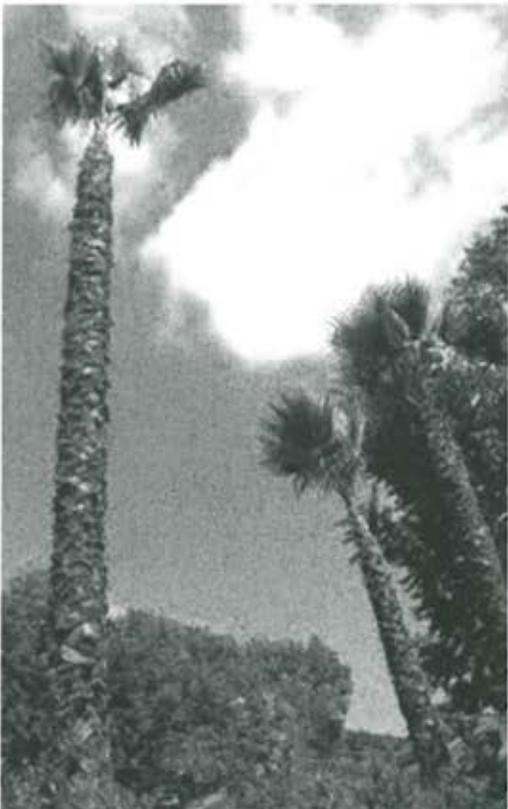
Appendix 4: Examples of trunk tapering from over pruned palms

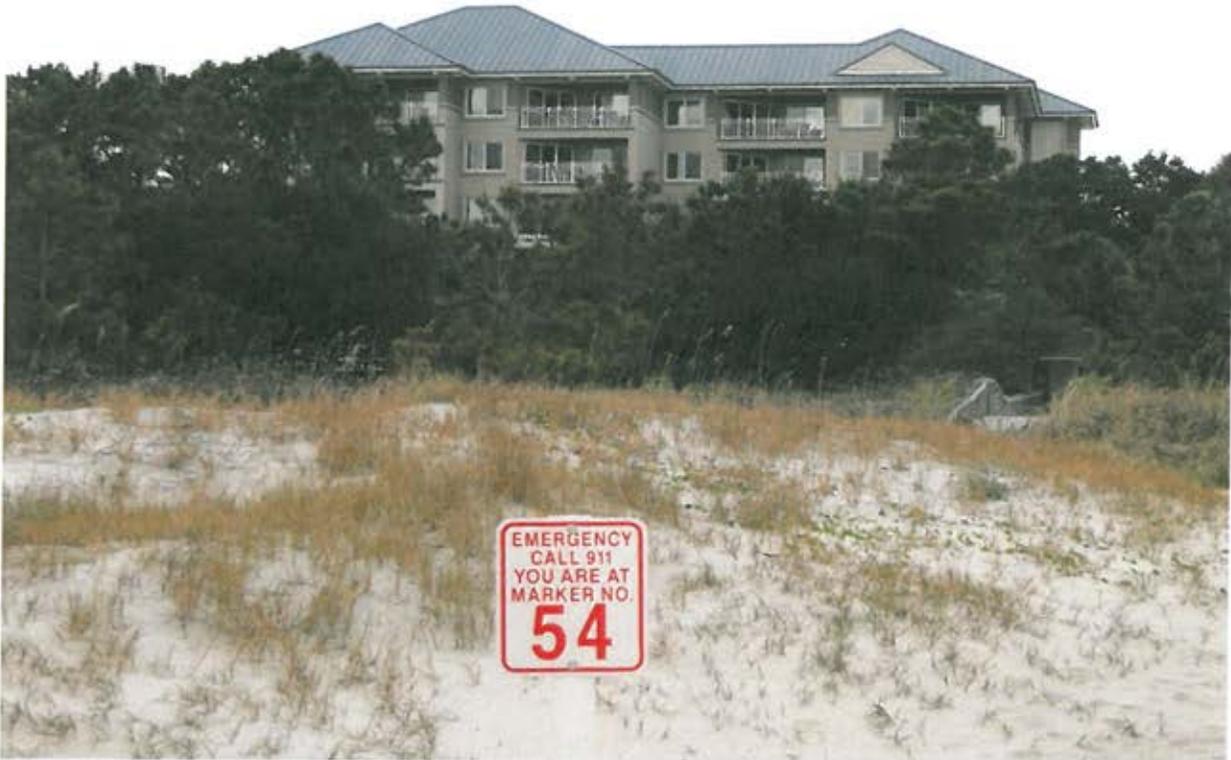
Northern Property Line- No requested trees against Building 80 are visible through dune growth and Pines

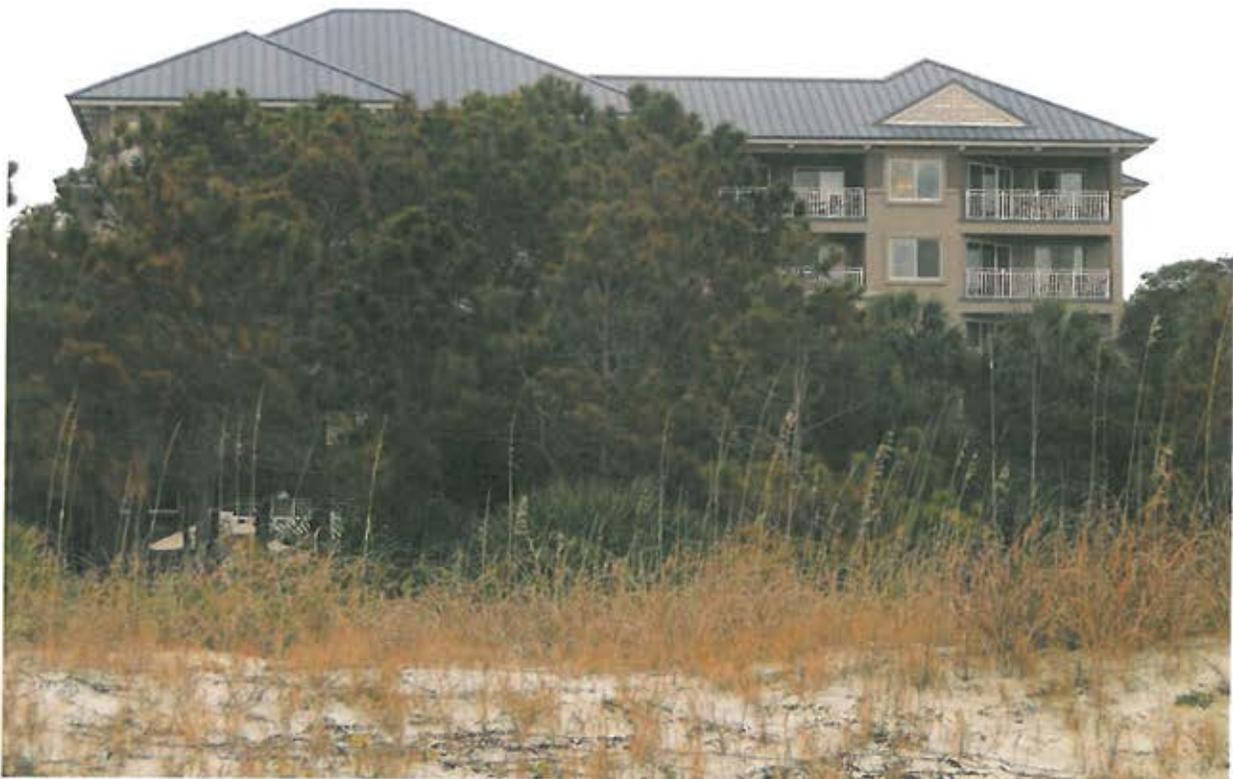
Middle of Building 80- View Corridor Pruning #2 where stand of Pines would have smaller trees removed

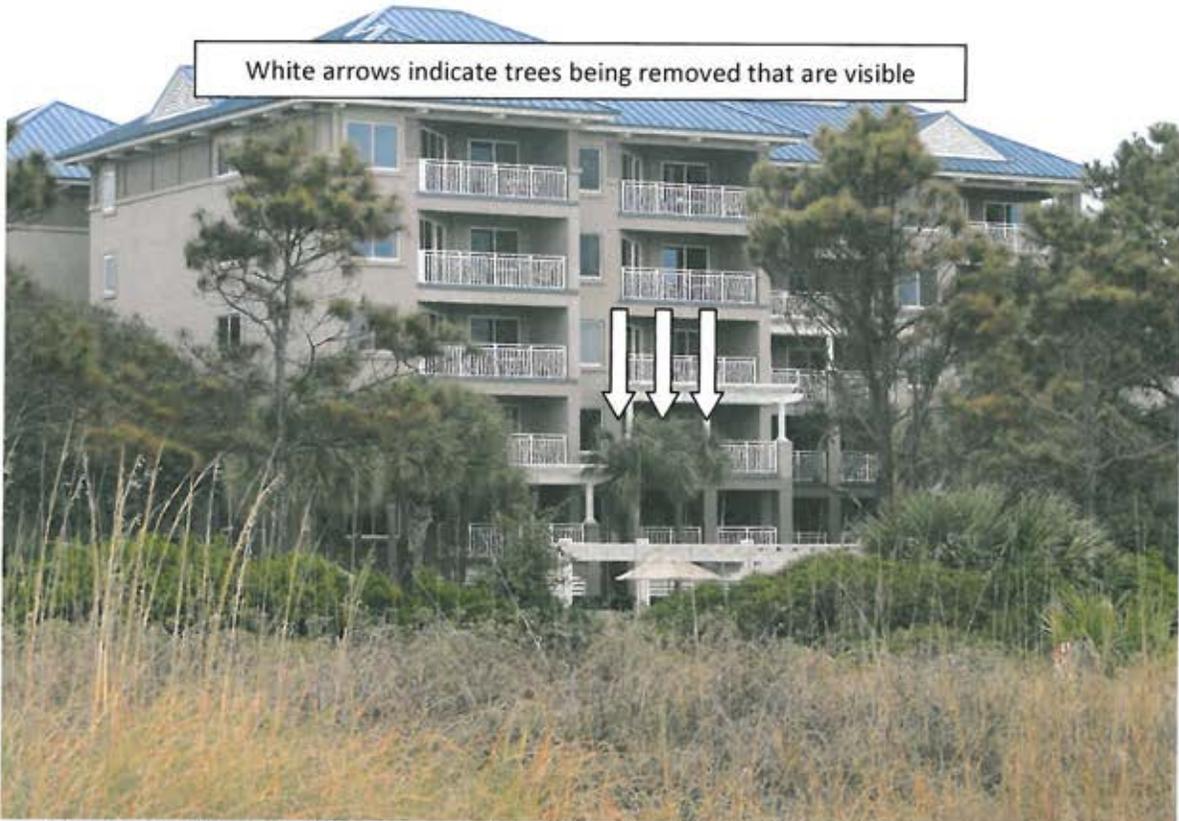
White arrows indicate trees being removed that are visible

View to Building 80 with southern angle- only center three palms against building are visible

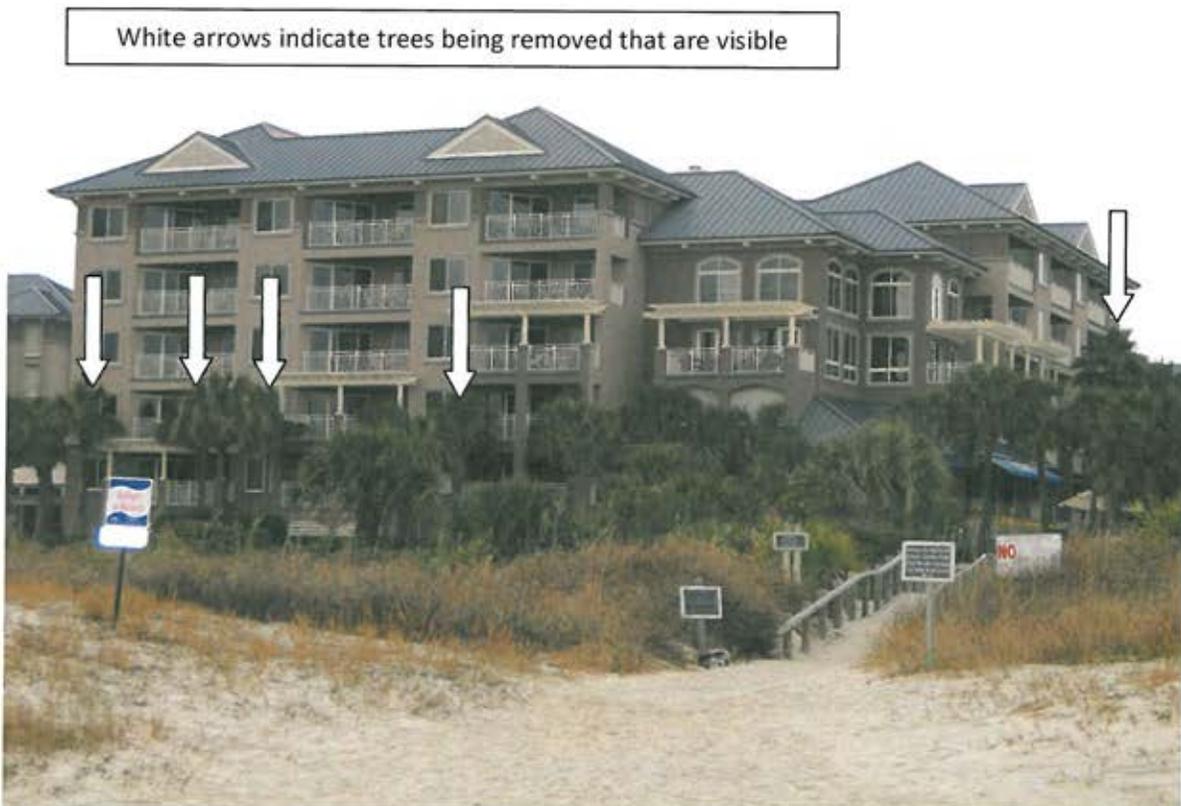
White arrows indicate trees being removed that are visible

Limited exposure to Building 84 from because of dunes growth and foreground palms that will remain

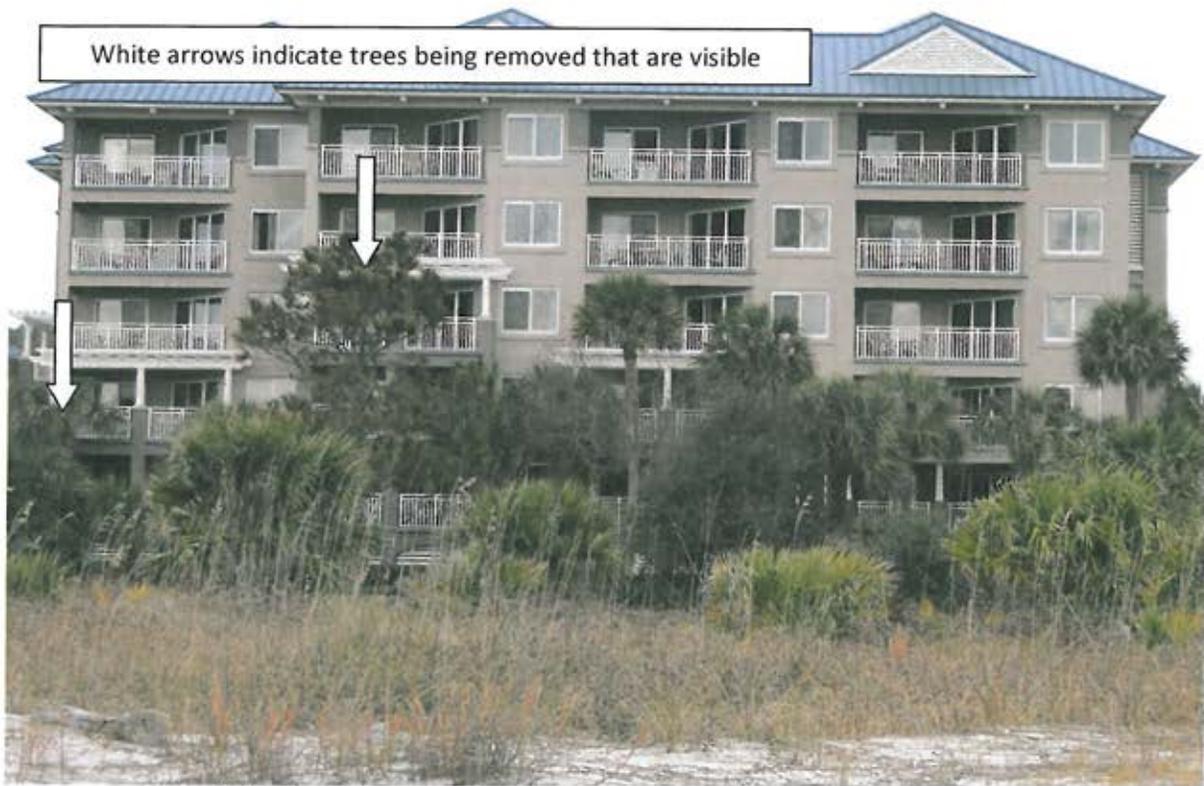
Building 85- Dunes growth and foreground palms dilute view to building

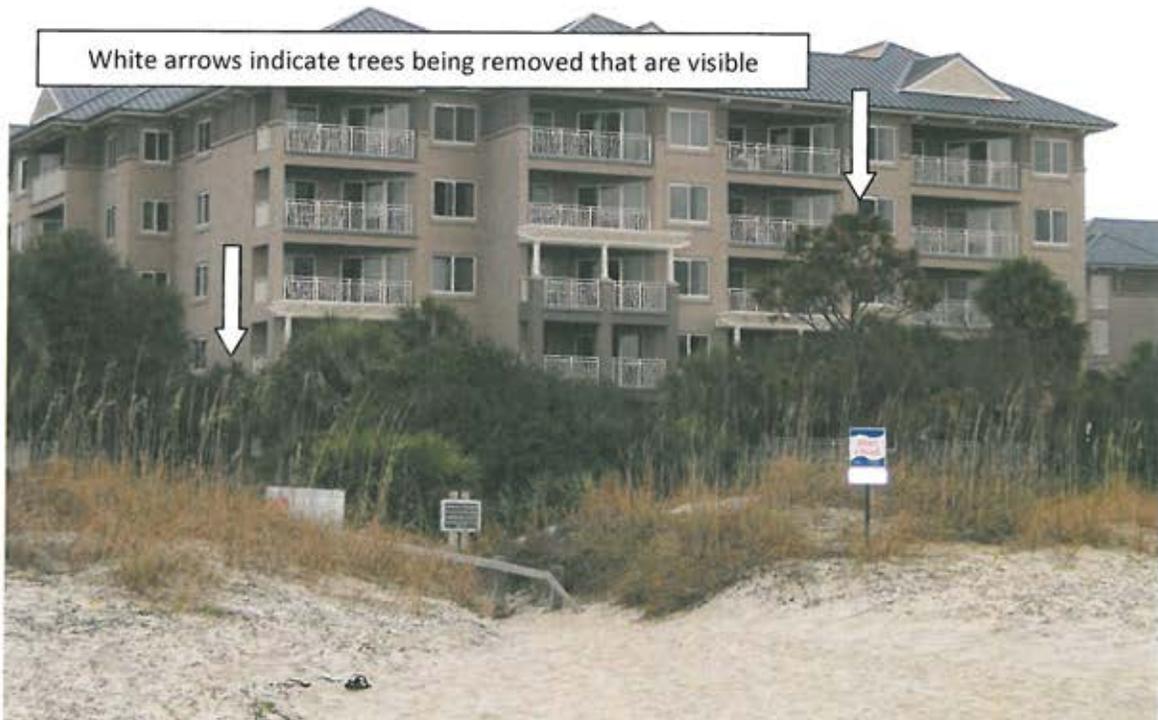
Building 85- Southern angle

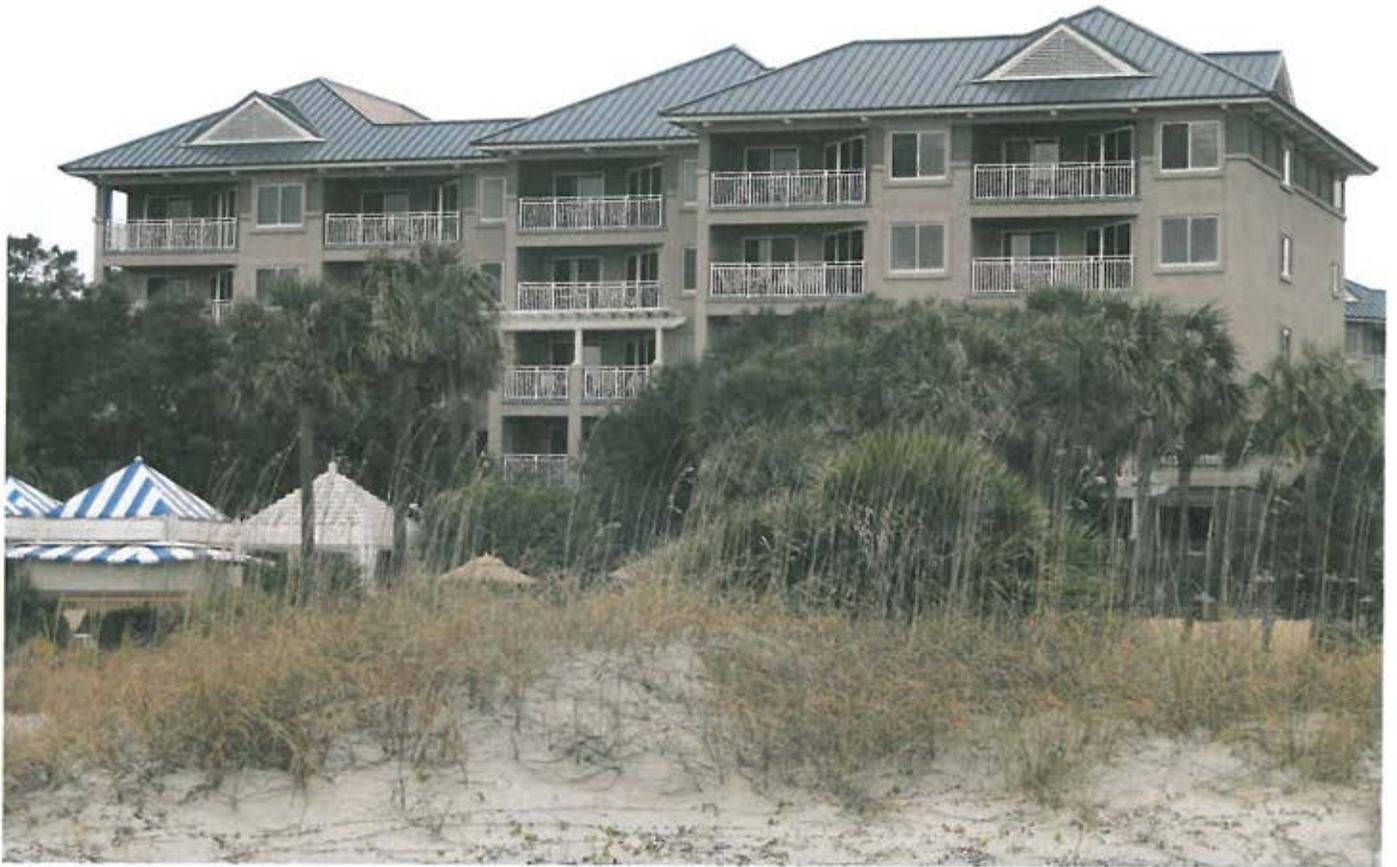
Building 89- No palm or Oak removal as requested in View Corridor #5 is visible from beach do to large number of palms on pool deck and remaining Oaks that are much larger
